Executive Summary

On October 10, 2006, Baltimore City Fire Fighter [FF] Allan Roberts, Fire Fighter/Paramedic Apprentice [FPA] Brandon Mattox, and FPA James Butler sustained injuries in the line of duty while battling a two-alarm fire located at 514 South Macon Street in Baltimore City. FPA Mattox and FPA Butler survived their injuries. Sadly however, FF Allan Roberts died as a result of his injuries.

As a result of this incident, Baltimore City Fire Chief William J. Goodwin Jr., appointed a reconstruction committee to investigate, evaluate, and make recommendations on the emergency response and activities conducted during and after this tragic event.

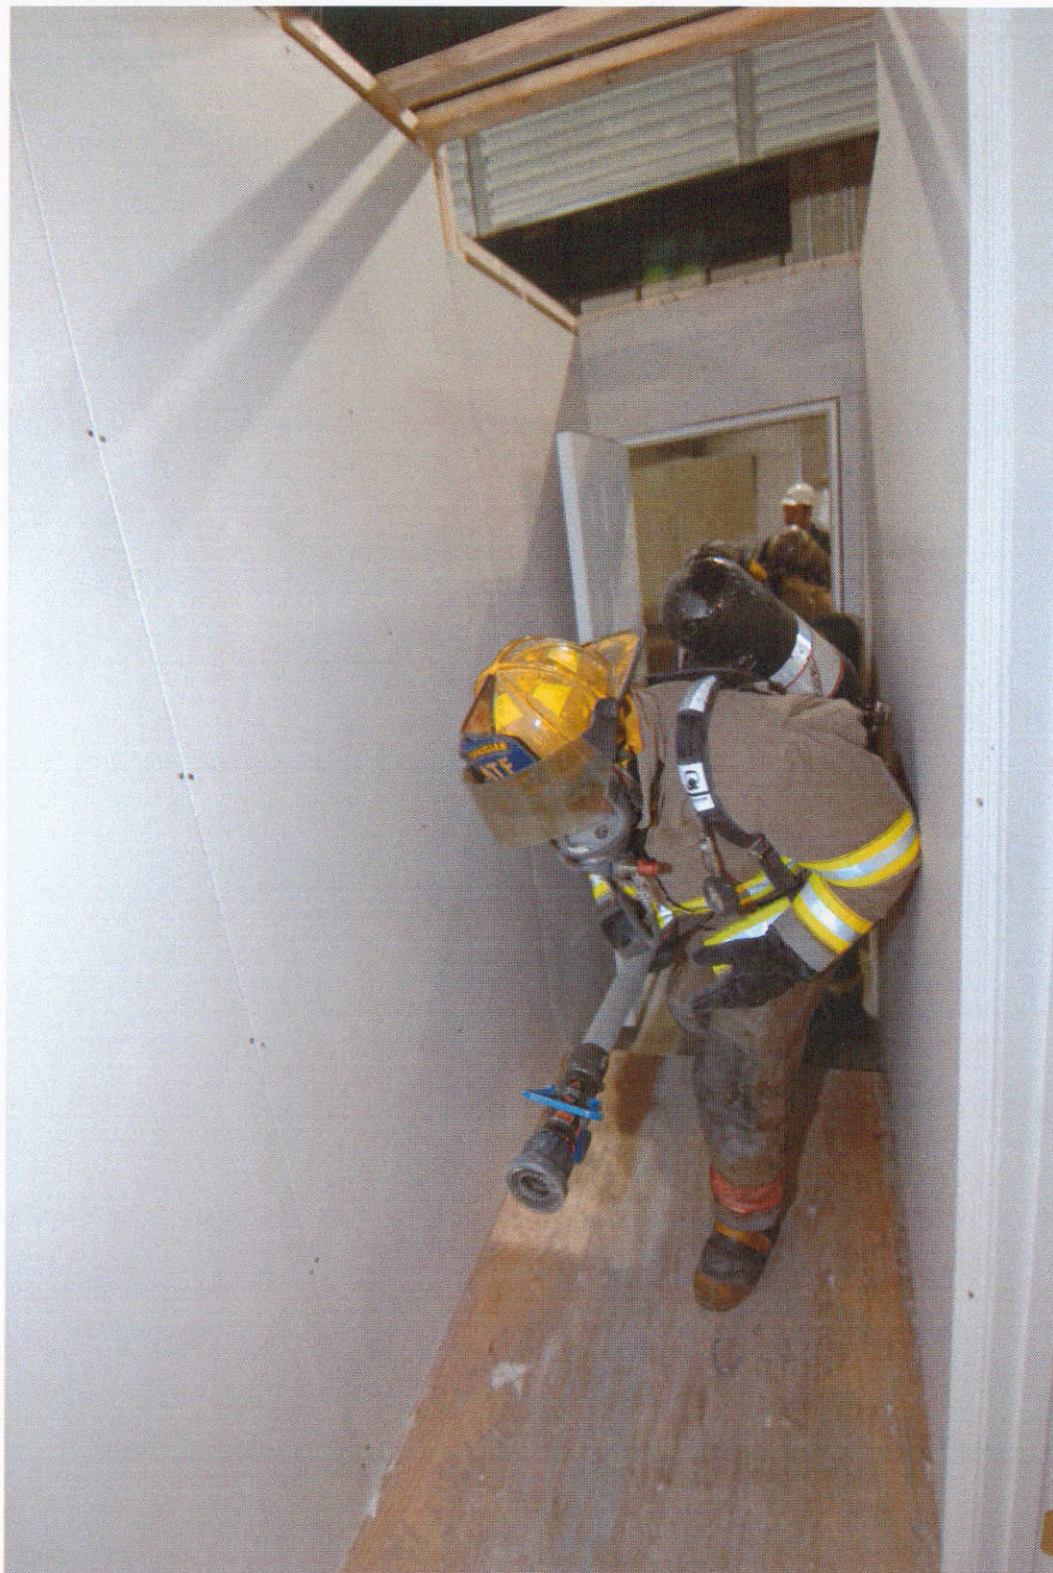
Re-enactment photo showing first hose line being advanced into the dwelling.

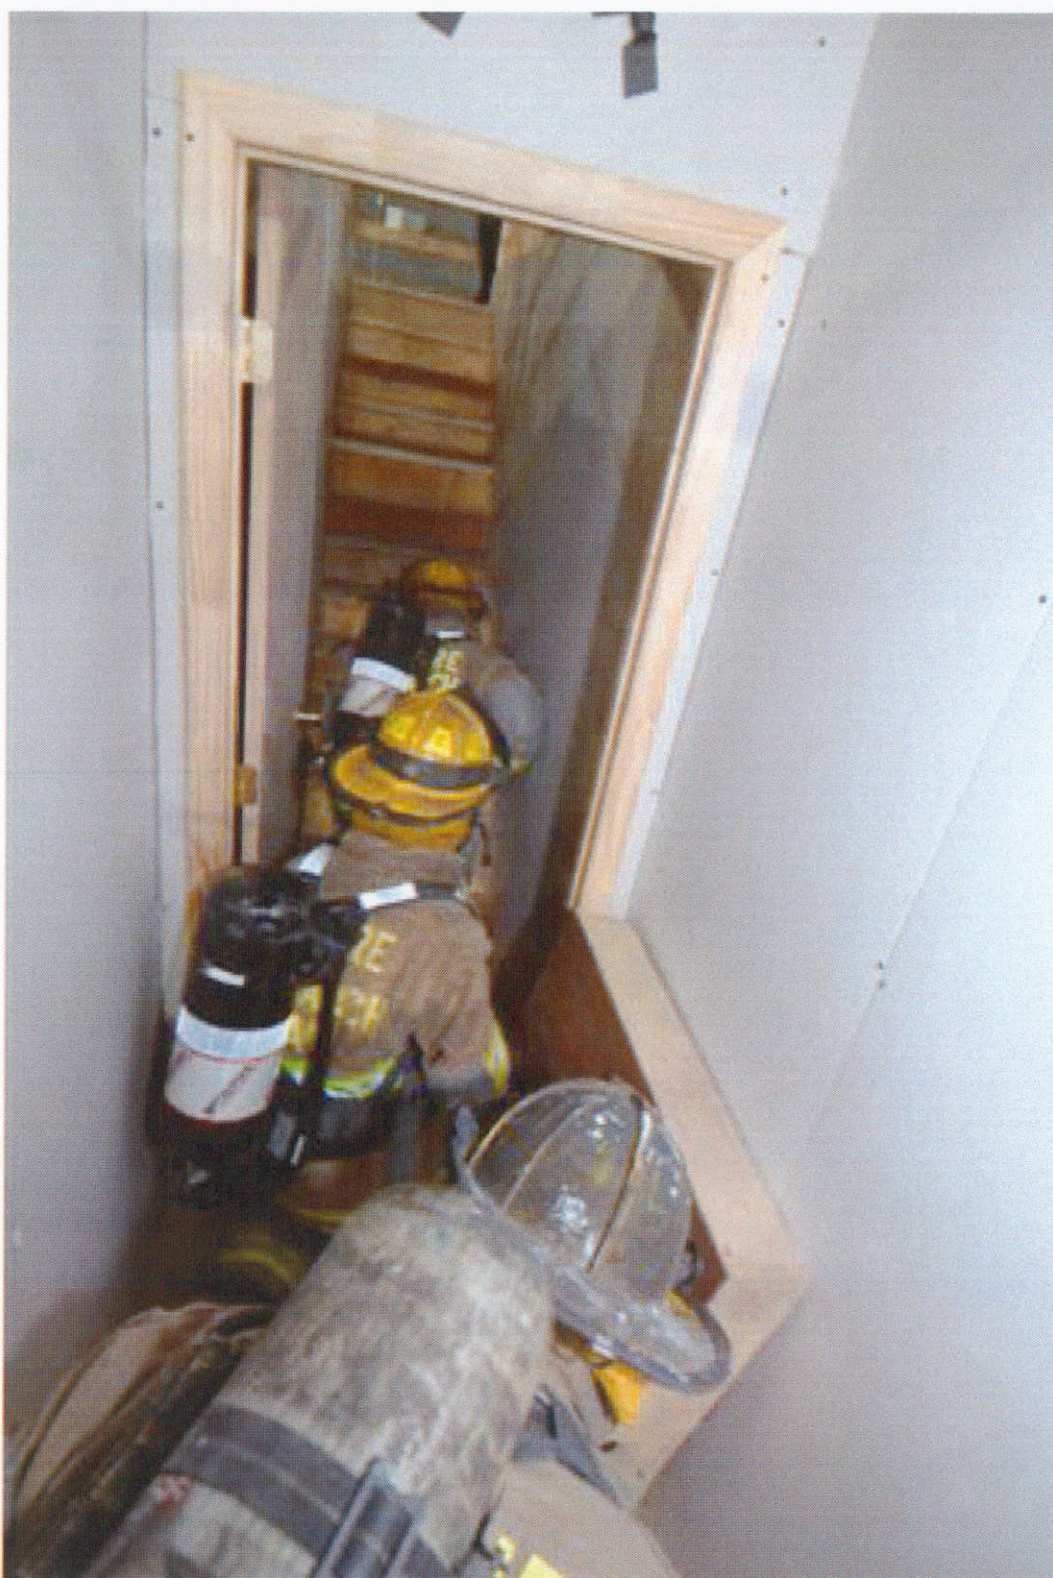
Re-enactment photo showing members beginning to advance hose line to the 2nd floor.

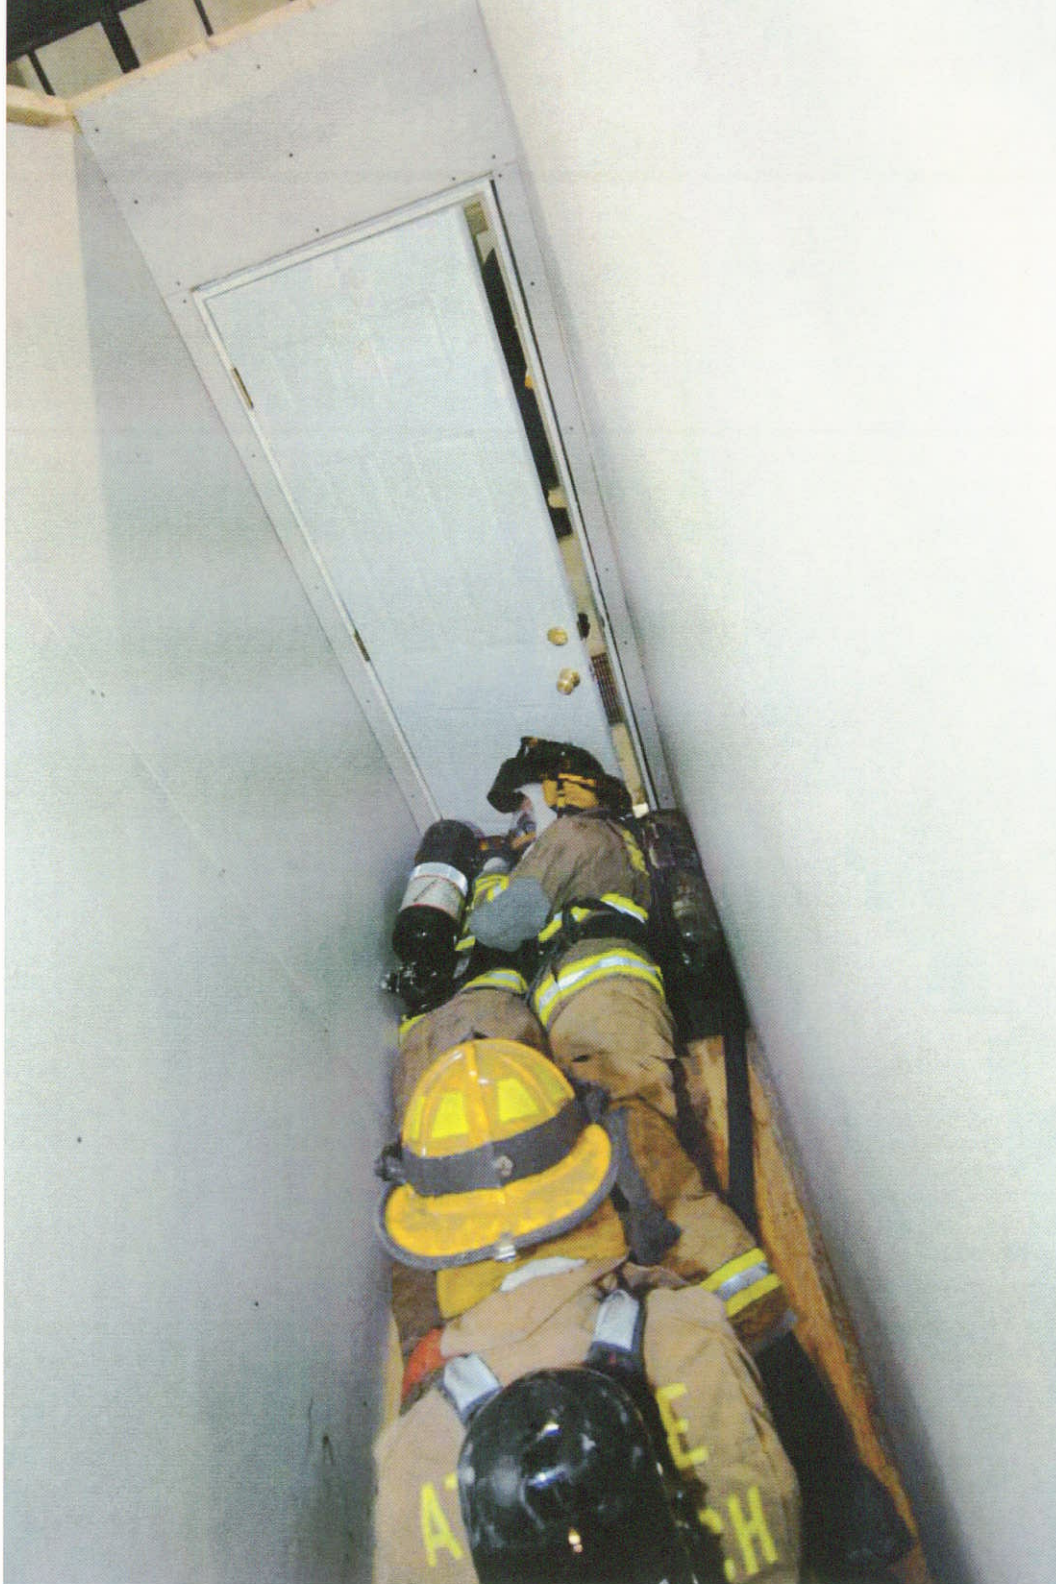
Re-enactment photo showing position of members after falling to the floor near the front door.

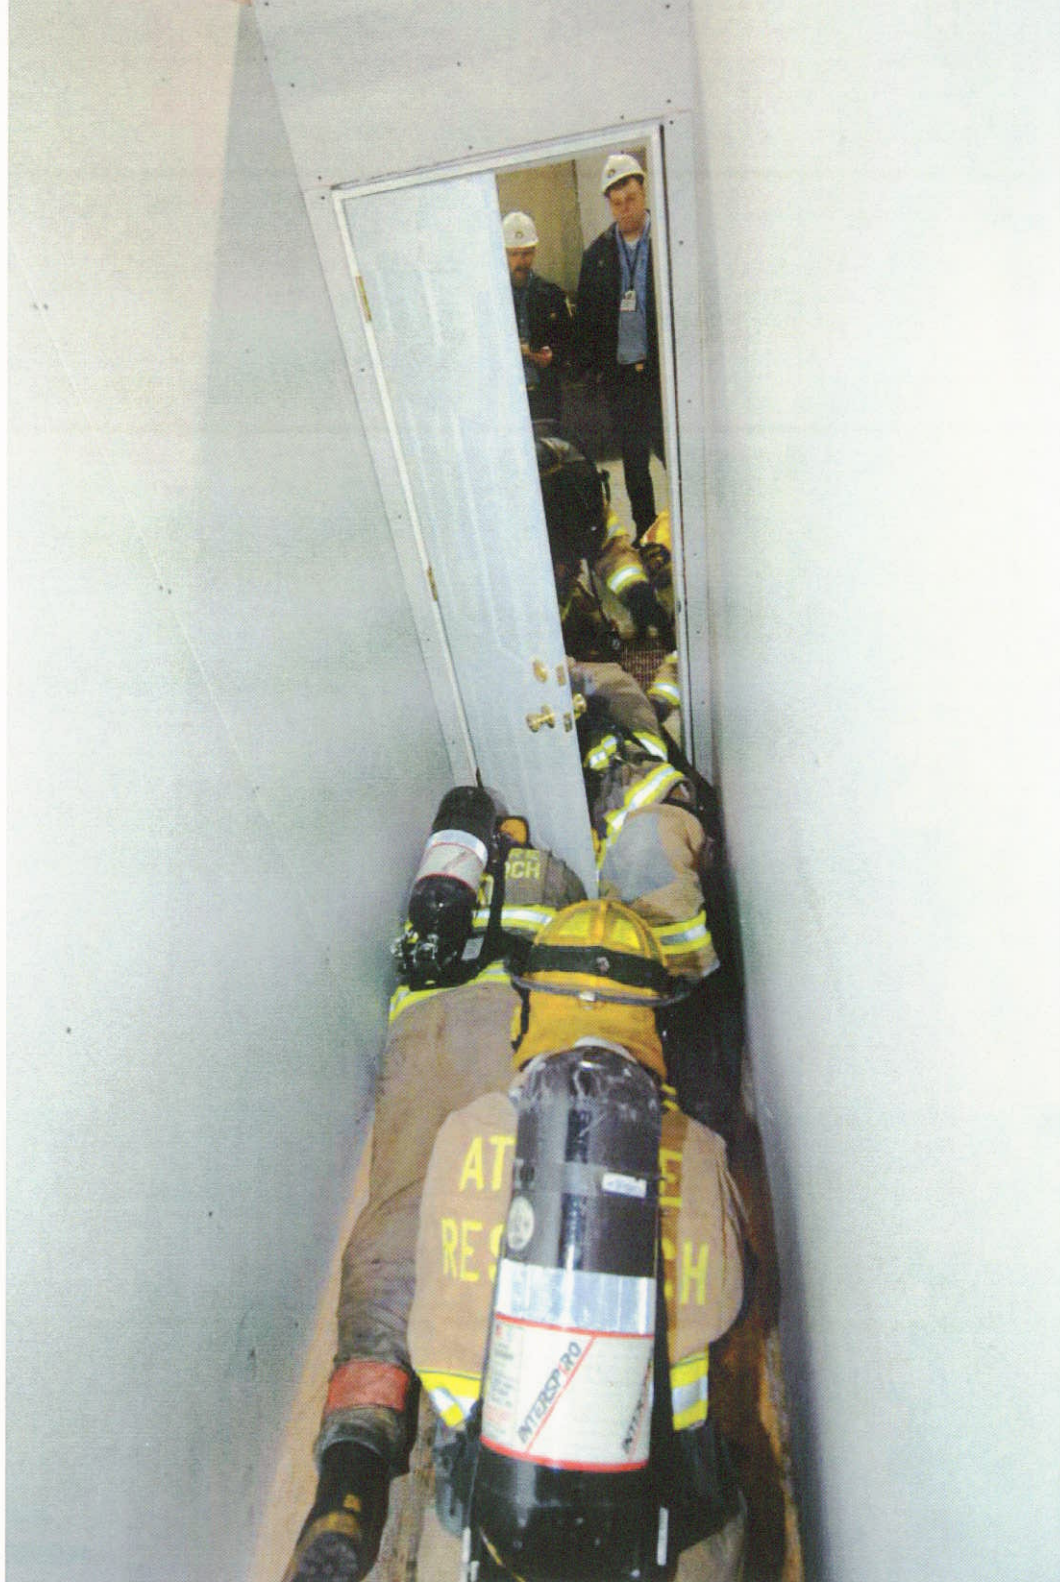
**Re-enactment photo showing FPA Butler
being pulled out of the dwelling by rescuers.**

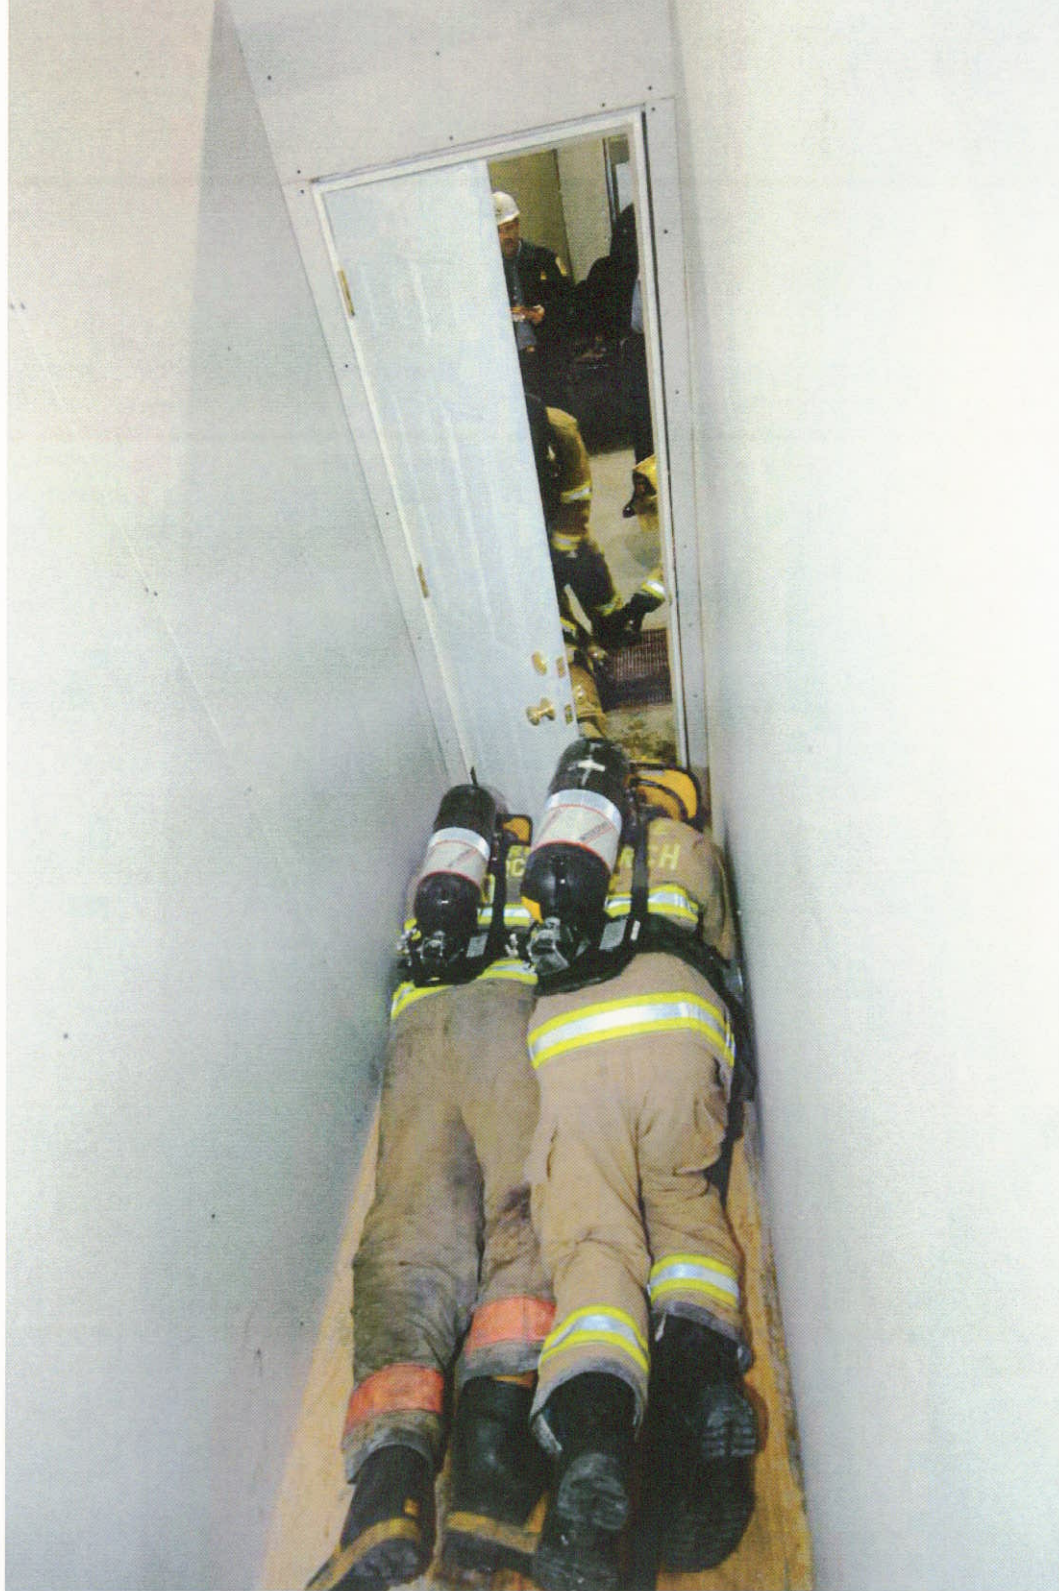
**Re-enactment photo showing FPA Mattox near the door
after the rescue of FPA Butler.**

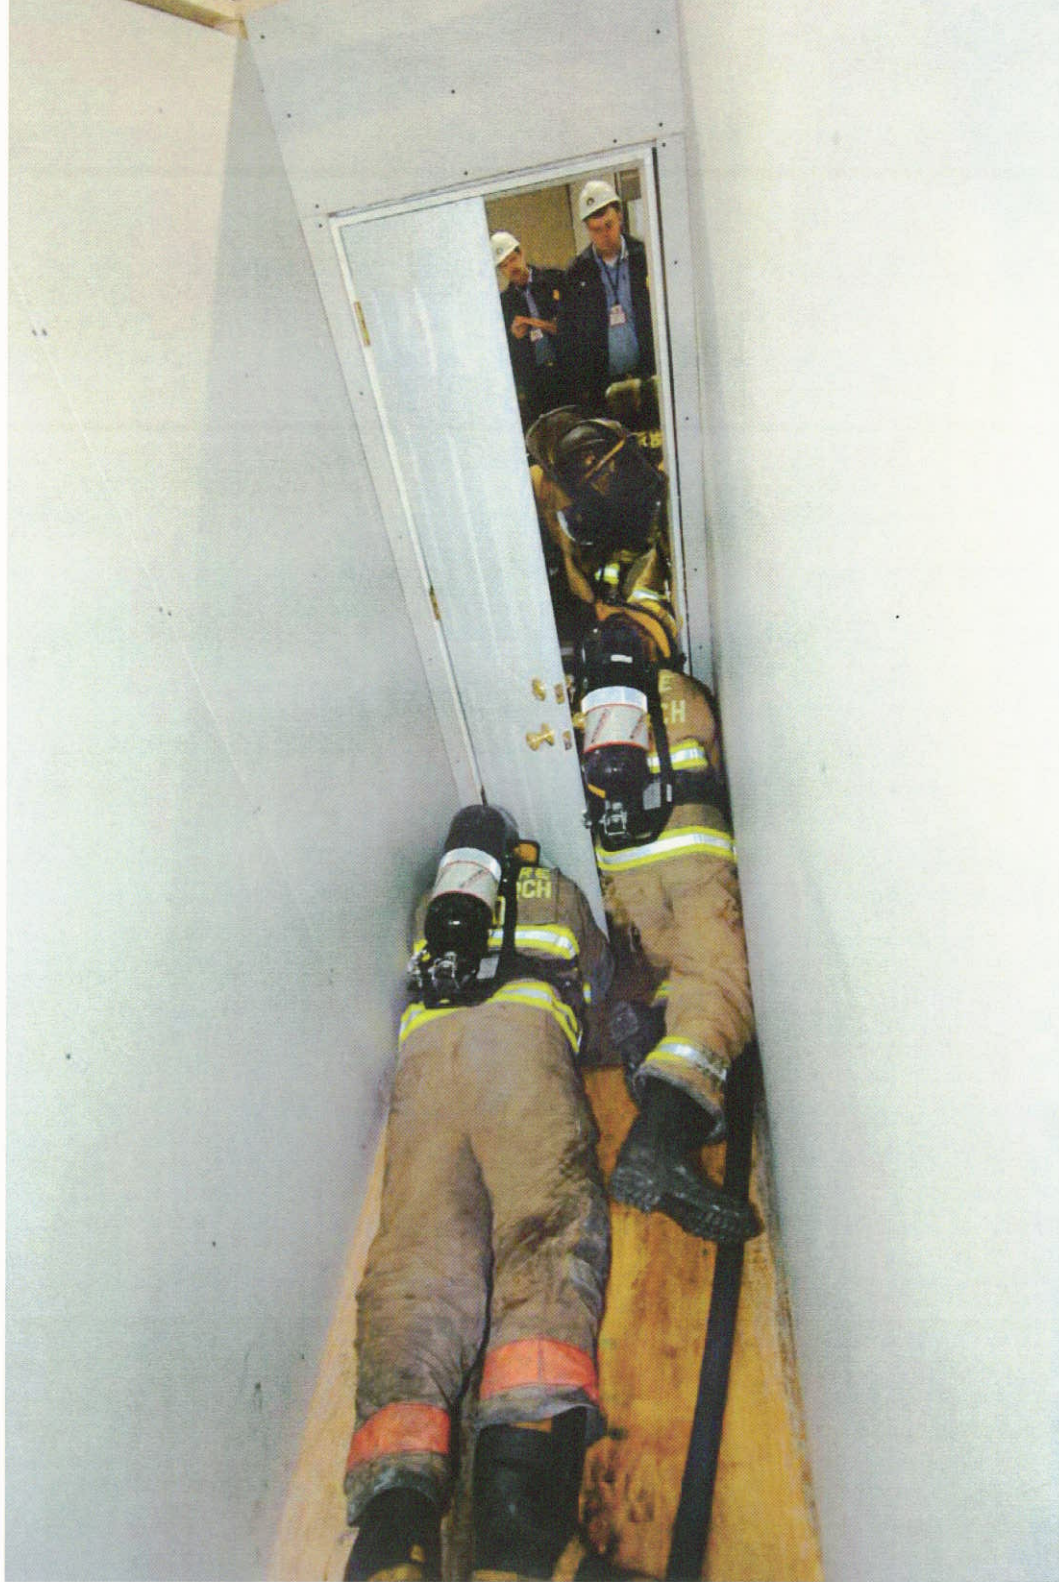
**Re-enactment photo showing FPA Mattox
being rescued from the dwelling**

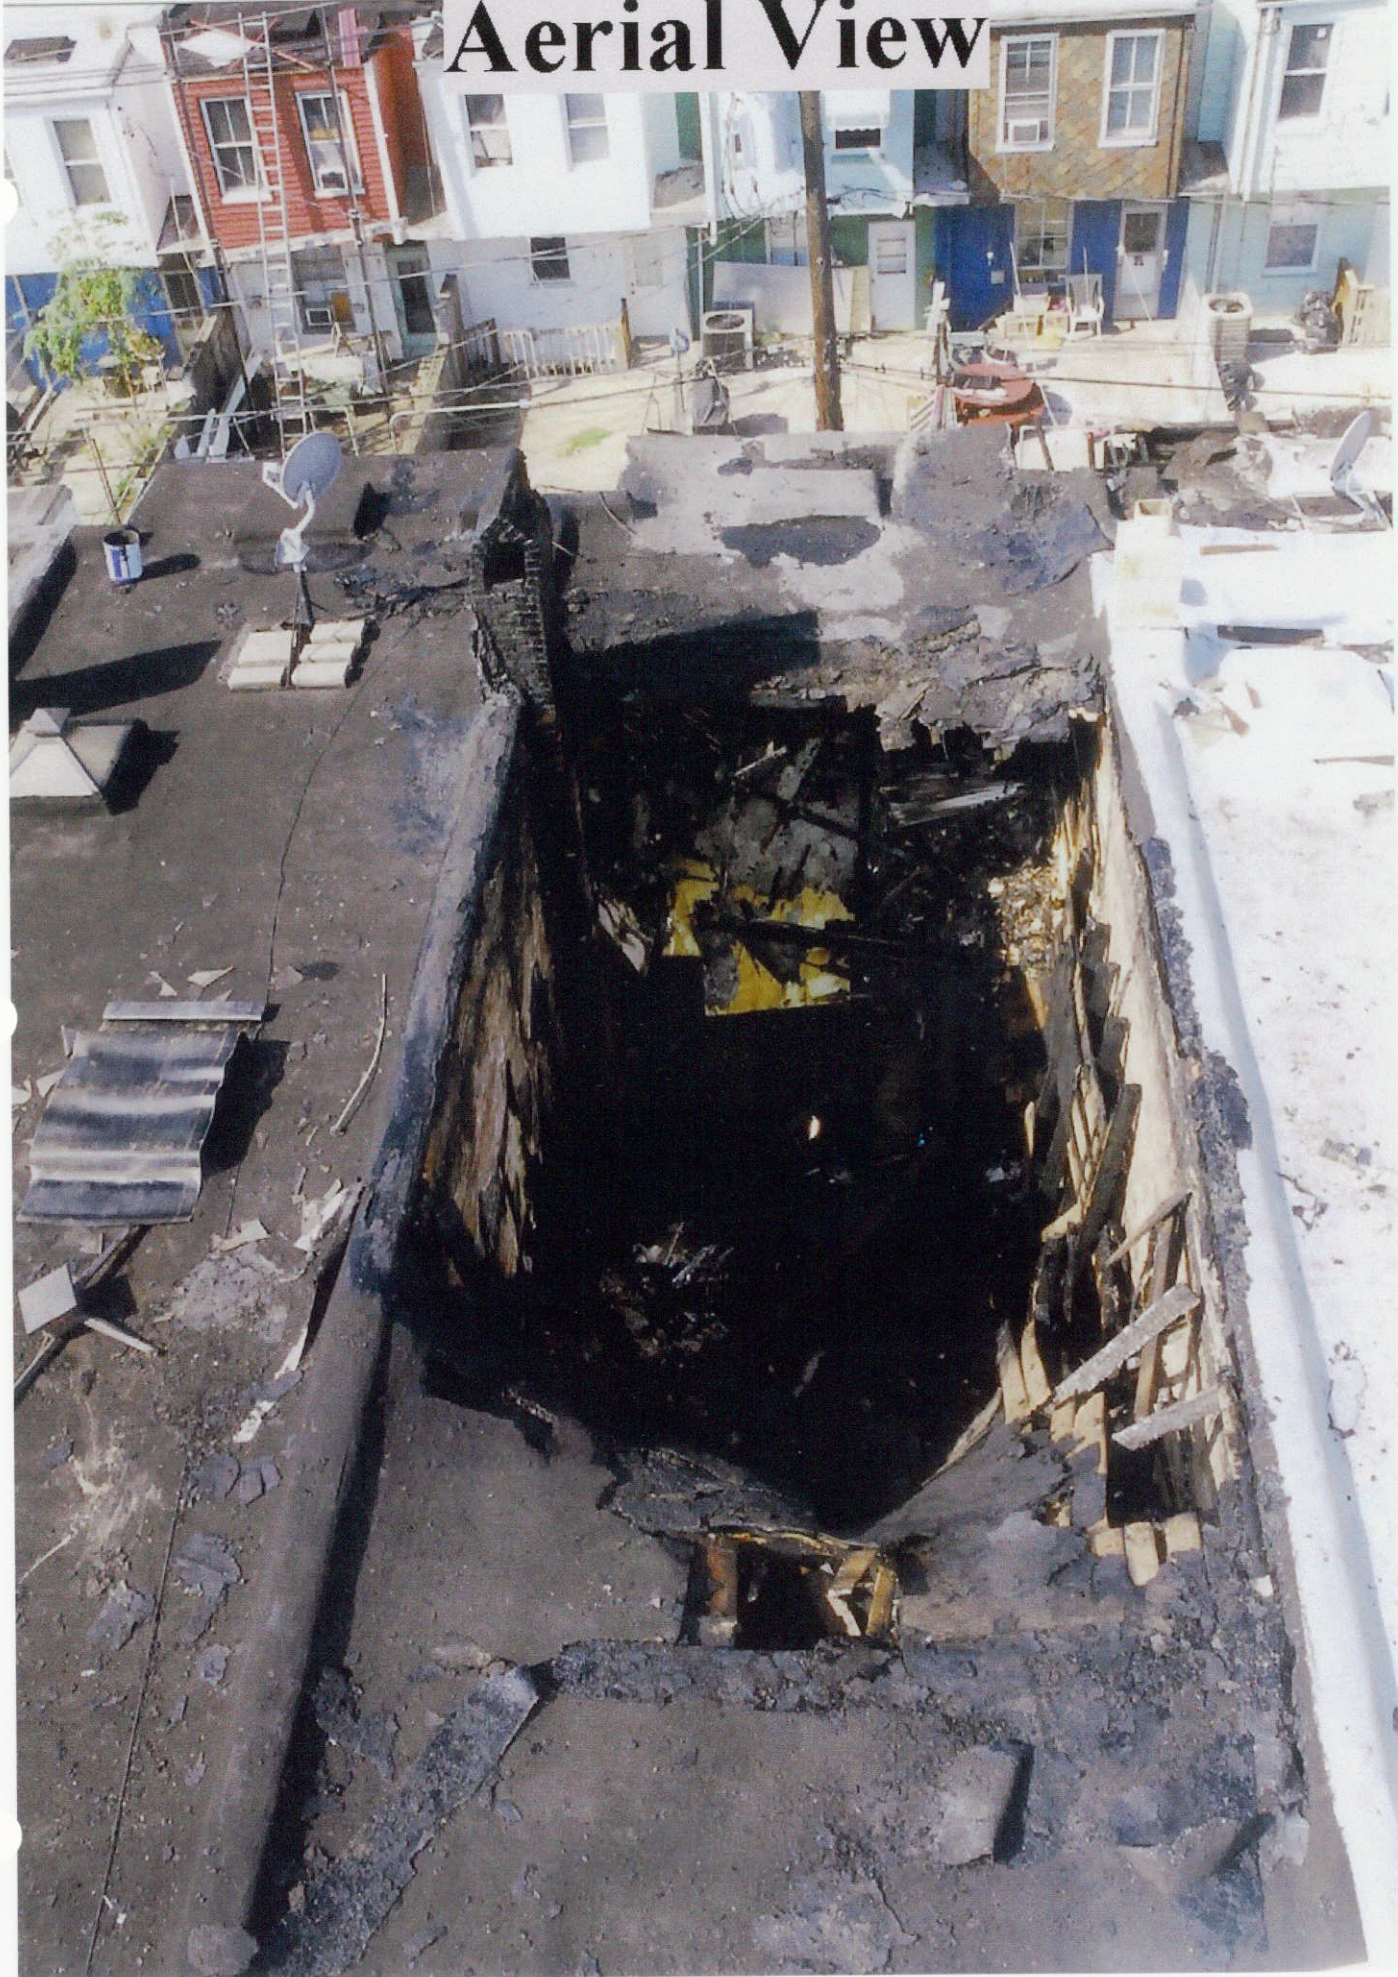
It is believed the above-mentioned remodeling greatly contributed to the fuel load [thin laminated paneling], the rapid vertical extension of the fire [large open voids behind the walls and ceilings], and the early collapse of the first and second floors, along with the roof area [exposed joist with previous fire damage]. [See figures 4, 5 and 6 on the following pages].

Hallway leading to stairs to 2nd floor

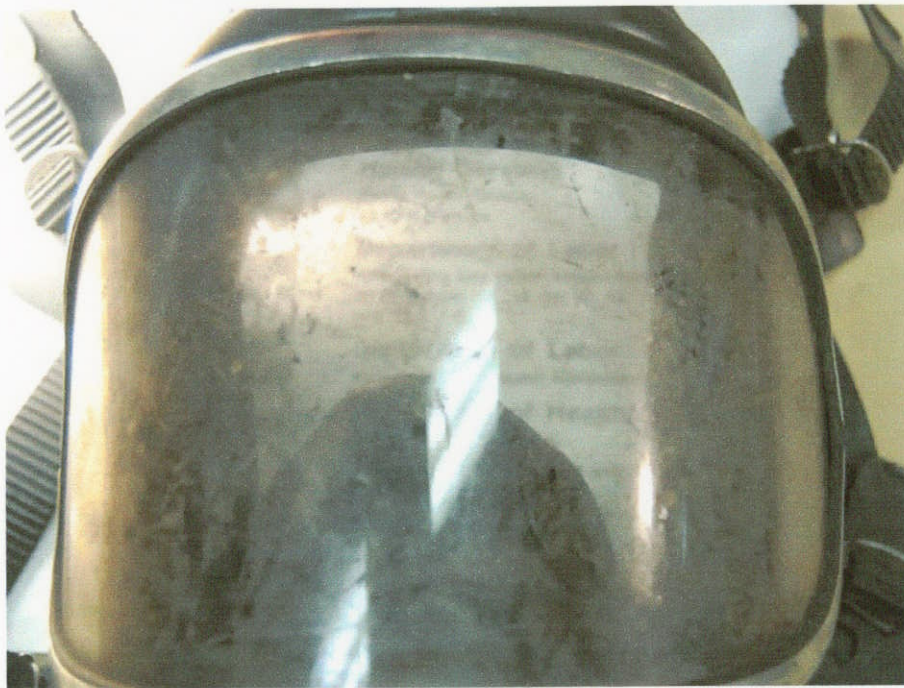
Figure 5 – Visibility through Facepiece Lens

1. Facepiece (Refer to Figures 4 through 6 in Appendix IV):

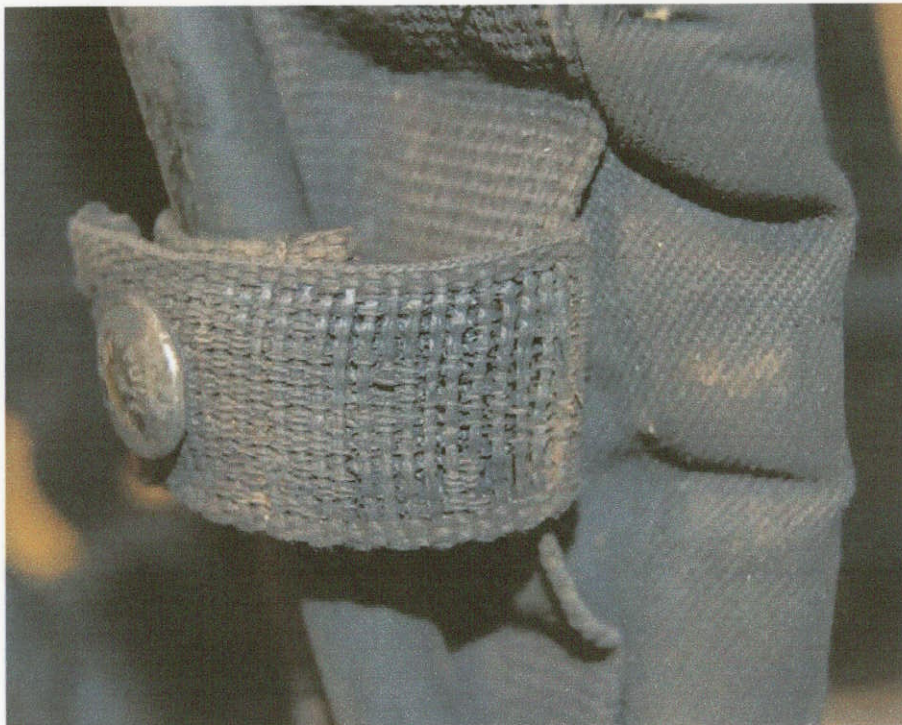
Figure 16 – Heat Damage to Shoulder Strap Webbing

5. **Backframe and Harness Assembly** (Refer to Figures 15 through 17 in Appendix IV):

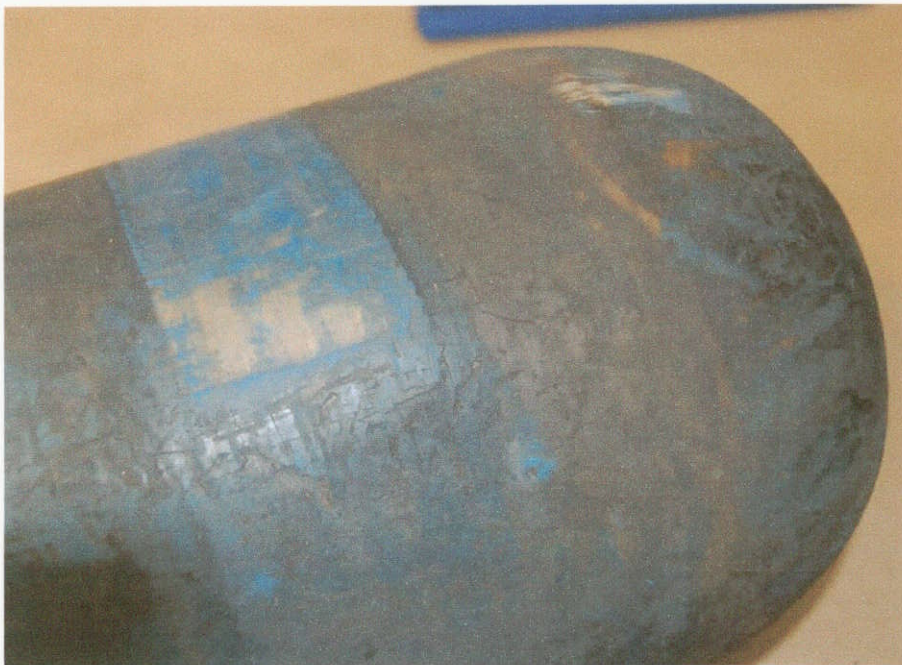
Figure 24 – Damage to Cylinder Composite Layer

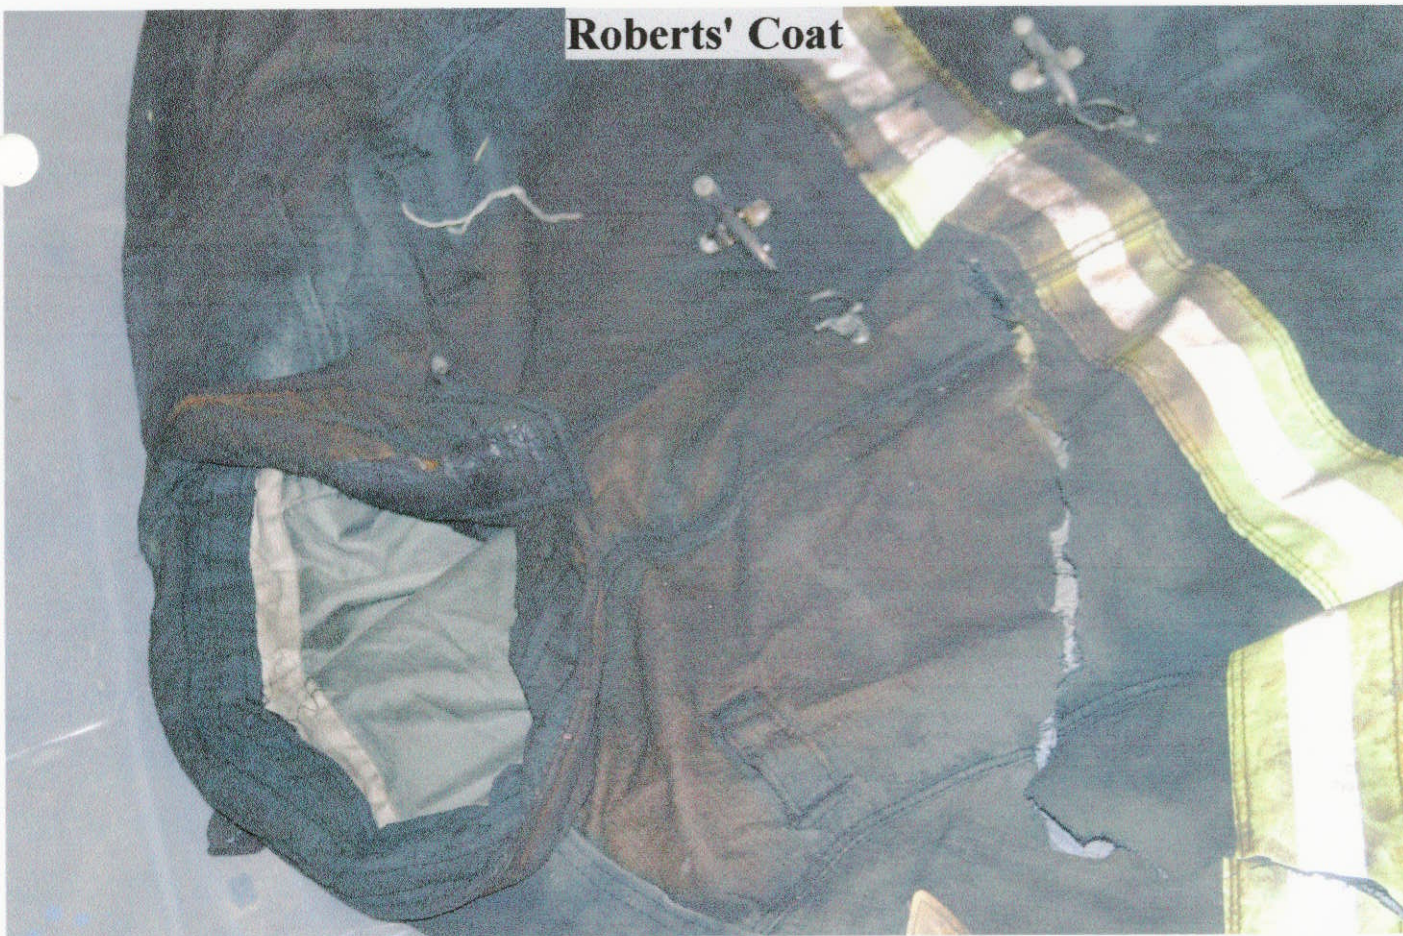
Roberts' Coat

The outershell of the coat exhibits reddening in the center chest portion of the garment. The left upper arm of the coat sleeve is discolored and the right sleeve is mildly discolored. The outer shell on the collar of the coat has also reddened in color. All areas of the outershell material are still supple and could not be torn by hand or by attempting to push through the material. The hook and loop closure on the throat tab has melted. The reflective trim is heavily damaged in several locations. The center portion of the chest trim has turned black and is starting to bubble. The left upper arm band of trim has discolored and the substrate has been exposed. The trim on the left arm has been discolored to a brown/black color. The chest trim on the back left side of the coat has blackened.

The shoulder pads inside the outer shell have melted and stuck to the adjacent outershell and thermal liner materials. The leather shoulder caps on the outside of the shell have stiffened. The majority of the damage to the coat is located from the chest trim up.

The coat liner was cut open by EMS at the scene, therefore the moisture barrier inside the liner was able to be inspected. The moisture barrier was discolored in the areas of the damage to the outer shell. The film was browned, however all seam tape remained intact.

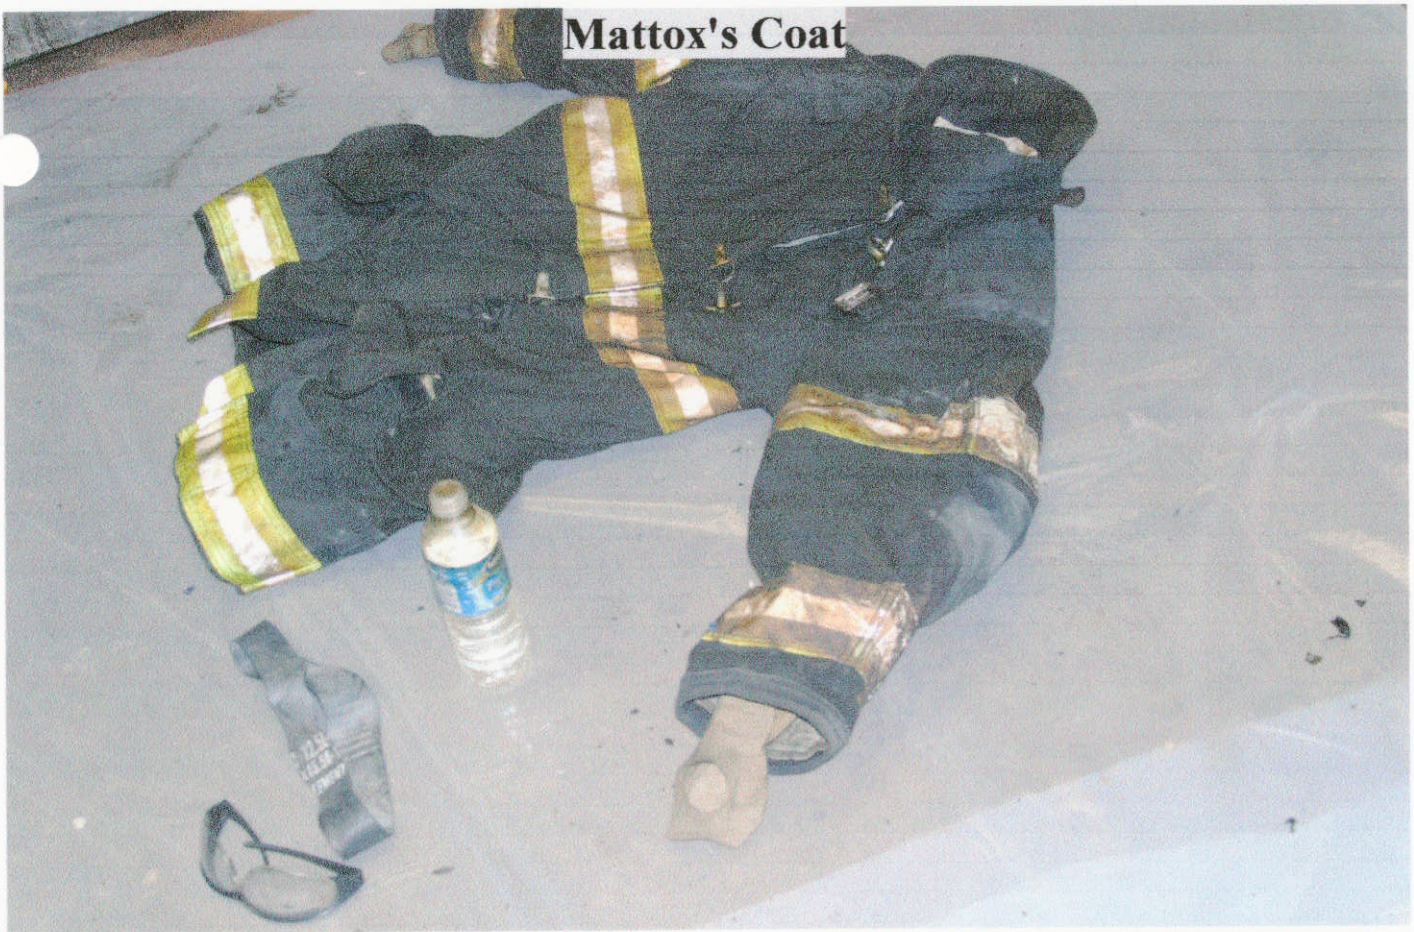
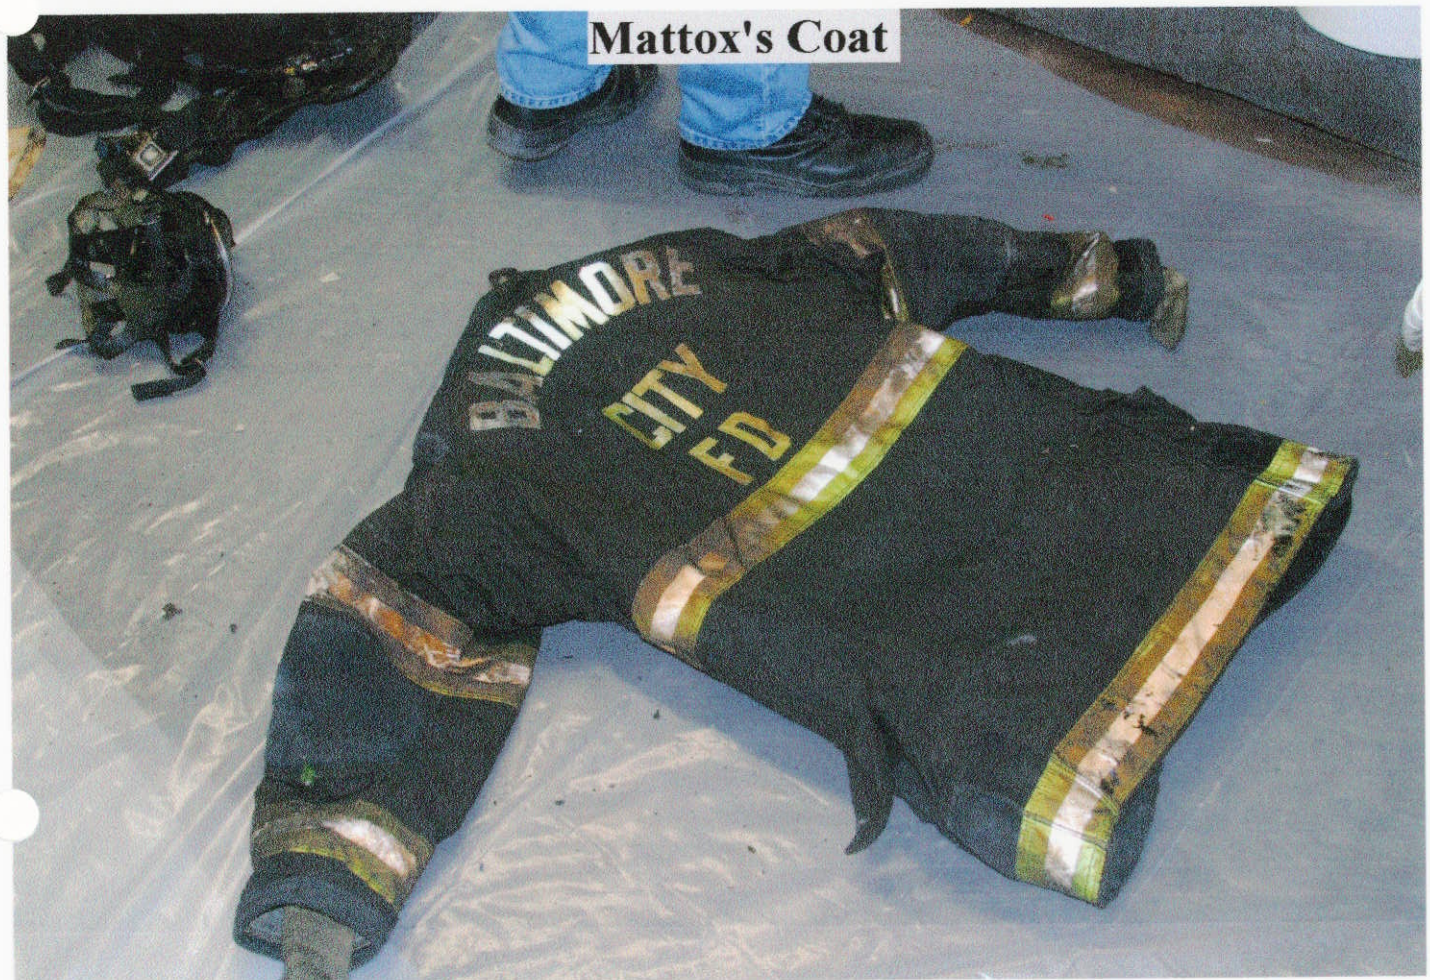
Mattox's Coat

The outershell fabric has turned slightly reddish in color in the area of the upper shoulders. The left upper arm band of trim has been burned and the substrate of the trim is exposed. All areas of the trim on the coat have turned a slight brownish/reddish color. There is no evidence of charring or embrittlement of the outer shell. On the left side of the front closure there is a tear between one of the hooks and dees. Over the thumb wristlets were used, however the burn to the hand was in an area not covered by the wristlet.

The liner had been cut open by the fire department for further inspection. Based on viewing the materials, the moisture barrier had little to no discoloration or damage.

The face cloth of the Rebound thermal liner was discolored in the areas of the shell damage. The Rebound layer has stiffened slightly but it is still supple and strong. There is no damage to the glide face cloth. The liner materials are still very stable.

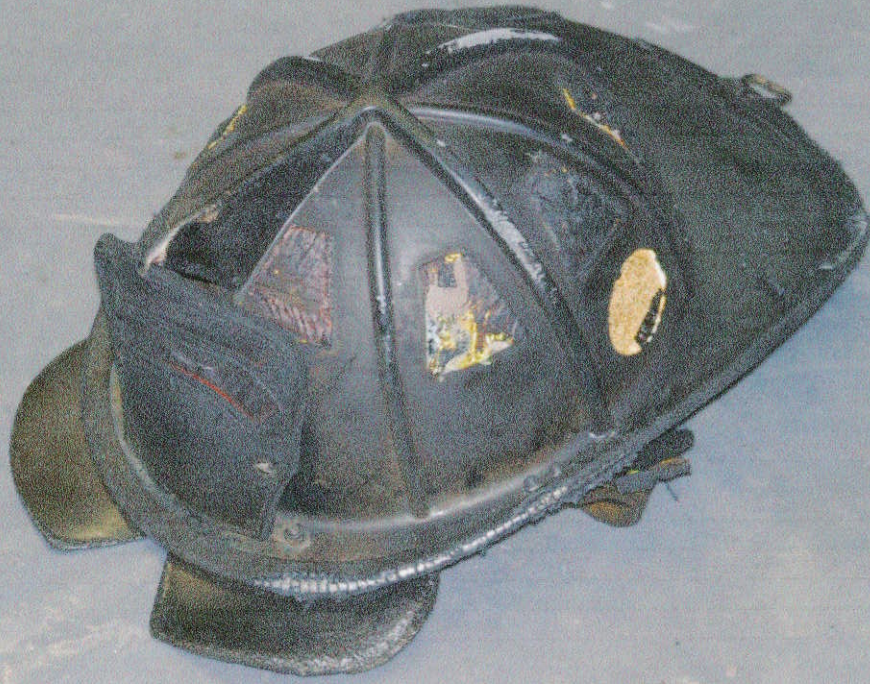
Mattox's Helmet

There was brown to black discoloration on the surface of the helmet. The welting on the helmet was either missing or damaged. The reflective trim on the helmet was charred and the Nomex ear cover was discolored but not charred. The flip down shield on the helmet were bubbling at the edges.

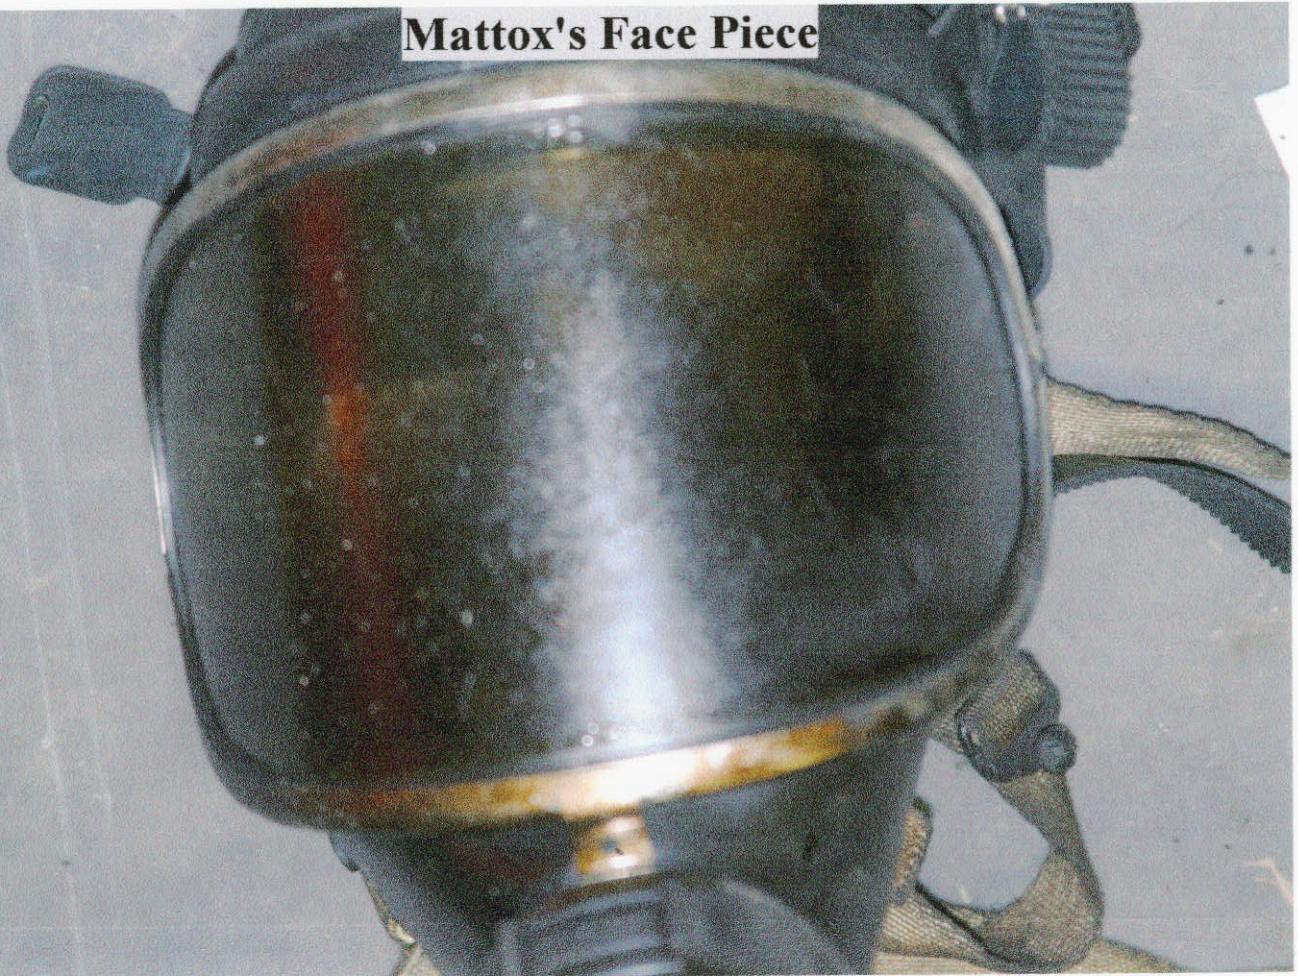
Mattox's Face Piece

The facepiece to the SCBA was observed and there was slight crazing to the lens of the facepiece.

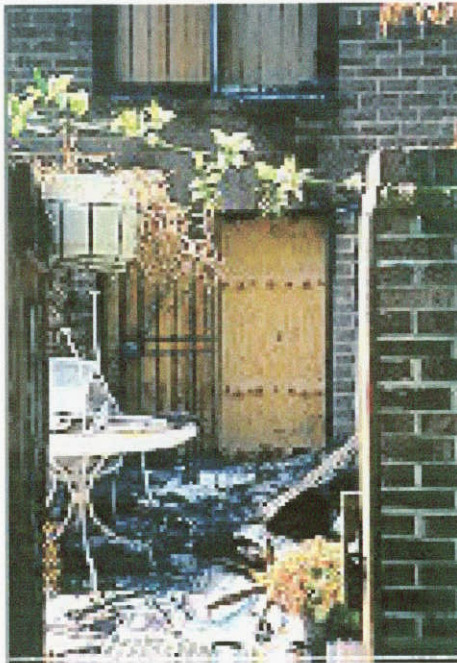
Photo 2: *This photo depicts the rear (side 3) sliding-glass door leading to the basement*

Engine 17 was now positioned at the rear sliding-glass door as Truck 4 prepared entry (basement level). Using a gas-powered saw and a sledge hammer, the officer and fire fighter from Truck 4 removed the iron security gate and broke open the glass door at 0026 hours (see Photo 2). Members of Truck 4 and Engine 17 stated that when the sliding-glass door was opened, air began to be sucked inside by the fire. They also saw small fires on the floor and stated that when the door was opened the fires grew larger. The Lieutenant from Engine 17 reported to the IC that they had fire on the first floor and requested permission to hit the fire. *[NOTE: Engine 17 was unaware that they were at the basement level due to the route they took to get to the rear. As they proceeded to the rear, they noticed the row houses they went between were only two stories, which caused confusion (see Diagram 1).]* The IC denied their request in fear of opposing hose lines. He then radioed the officer from Engine 26 to locate their position. He received no response from them. The IC knew that the crews from Engine 26 and Engine 10 had entered through the front door on the first floor.
